BMW E46 Convertible Hydraulic Line #23 Replacement Guide

Created by taylor192 of E46Fanatics.com

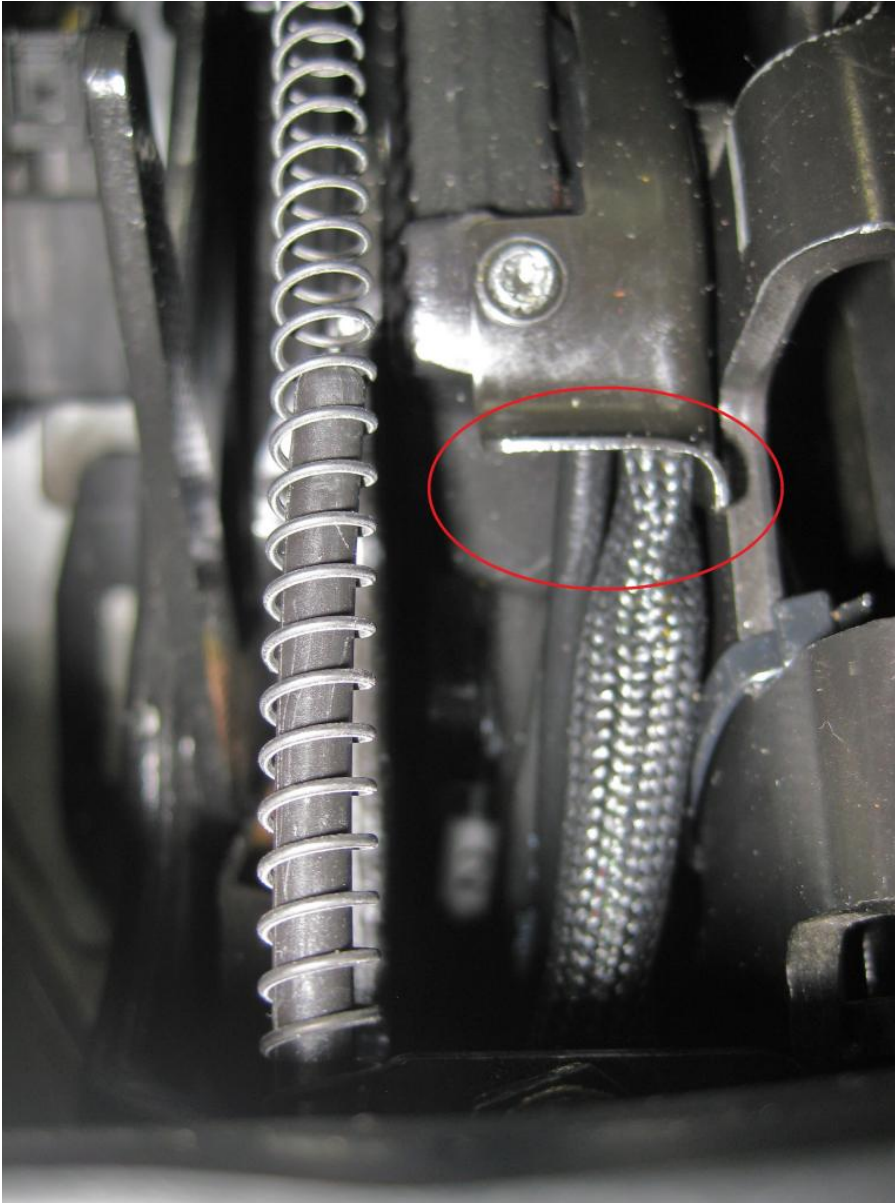
Look in this area for a crease in the line. You may have to raise the storage compartment lid (read the main lift cylinder DIY for manual operation of the top) and remove the protective cover (Step 4 of this DIY) to see it clearly. In this photo my line #23 has already been replaced (thus no crease):

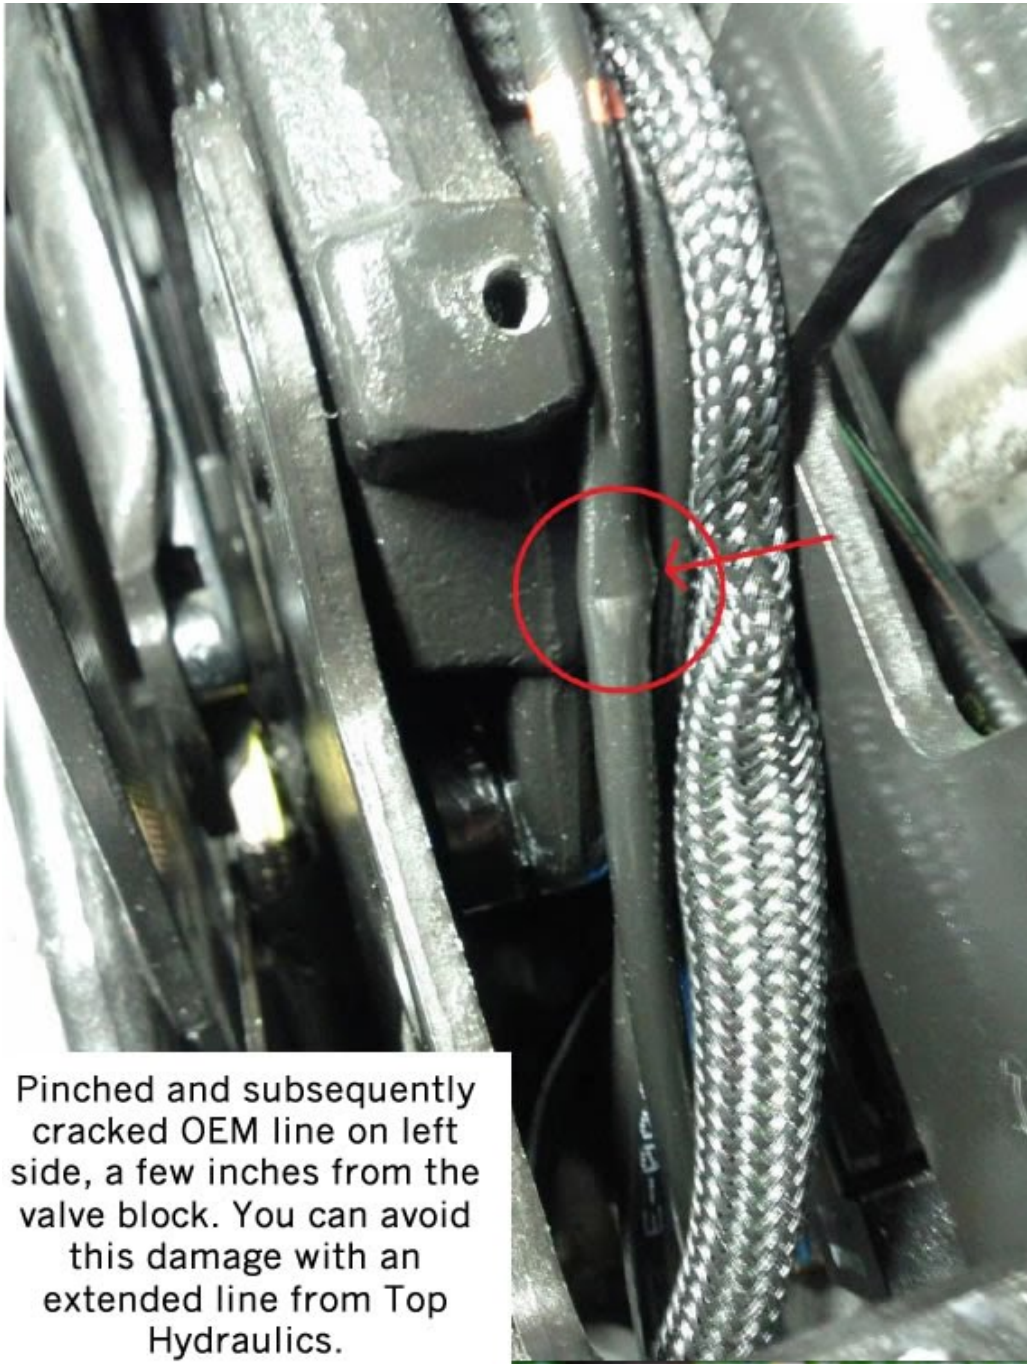
Line #23 runs from the valve block on the driver's side, over one of the tension bars on the top, to the passenger side main lift cylinder. On my vehicle line #23 had no slack between the valve block and the lowest joint (I'll call this the "first bend") nearest the drivers side main lift cylinder. This causes line #23 to be stressed when the rear window is lifted, eventually causing the line to split.

Here is line #23 with the protective cover removed. Note the crease and the split on the side.

Pinched and subsequently cracked OEM line on left side, a few inches from the valve block. You can avoid this damage with an extended line from Top Hydraulics.

My proposed solution is to reroute line #23 around these plates. This requires a longer line to reroute, as well to provide extra slack at the "first bend". Thankfully Top Hydraulics is able to manufacture a custom extended line #23!

Note: The line is 5 cm longer. 1 cm to provide extra slack at the "first bend" and 2x 2 cm to allow the line to be rerouted at the corners of the tension bar.

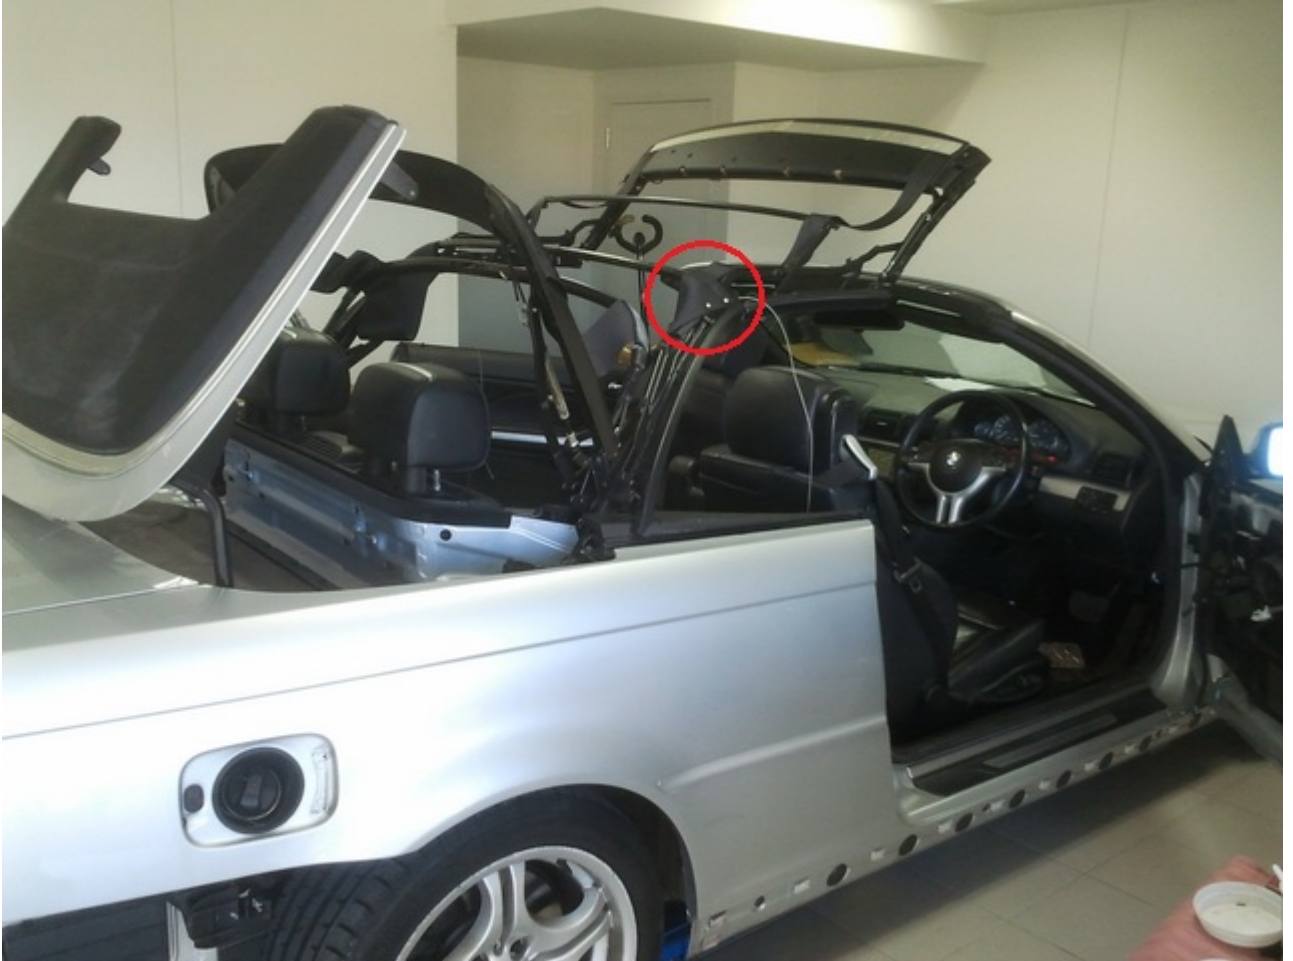
Replacing the line #23 is straight forward except for 1 issue. The line is routed under 2 plates on each top corner of the tension bar (circled red - you do not have to dismantle the top as shown in the picture below; the picture is for clarification only)

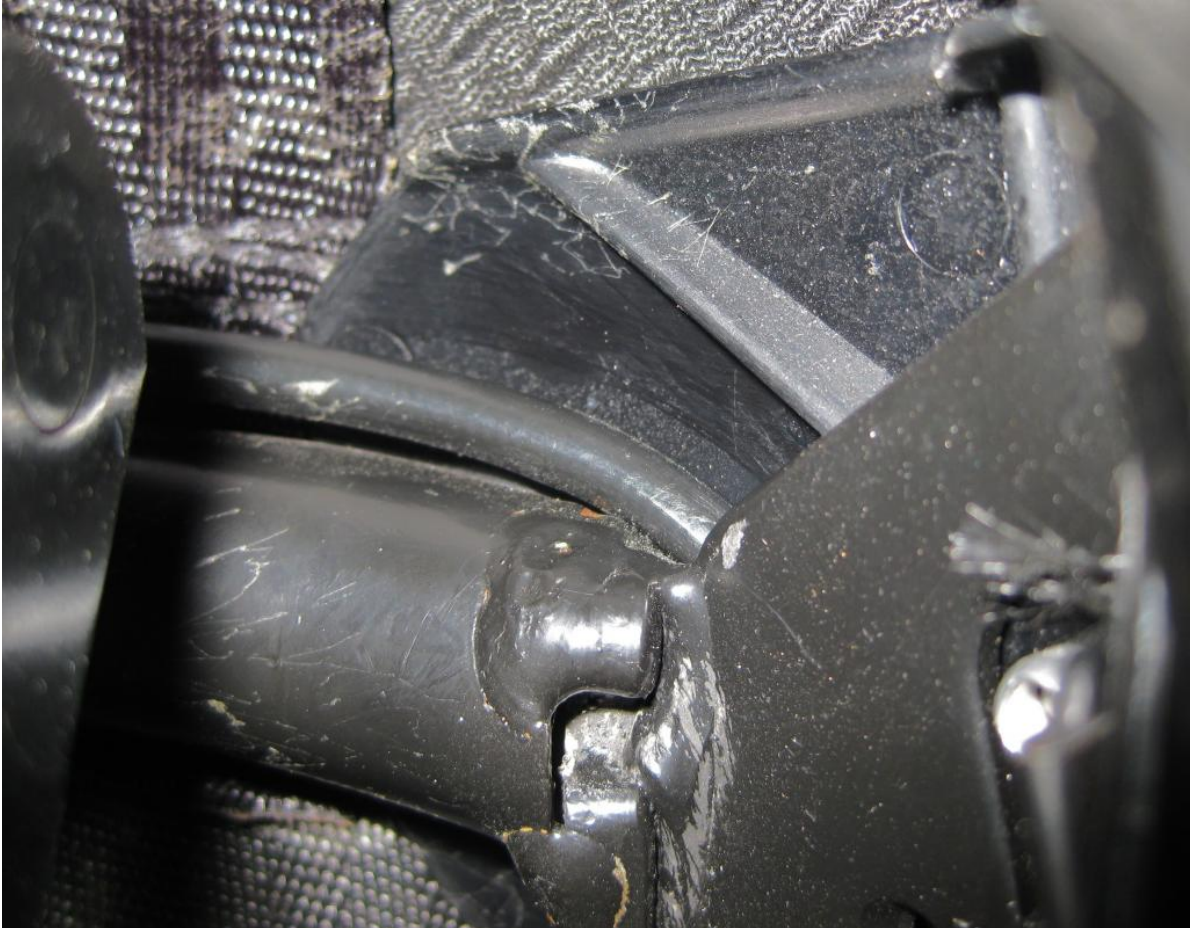
These plates have a channel that holds the lines securely between the plate and the tension bar. The channel is not wide enough to accommodate the fittings on the ends of the lines. The old line can be removed by cutting one of the fittings off, yet the new line cannot be routed under this plate with the fittings attached.

The plates are attached from the top with 2 rivets. To access these rivets requires removing/loosening the fabric from the top, which requires drilling out many rivets. This is not a solution I'd like to pursue.

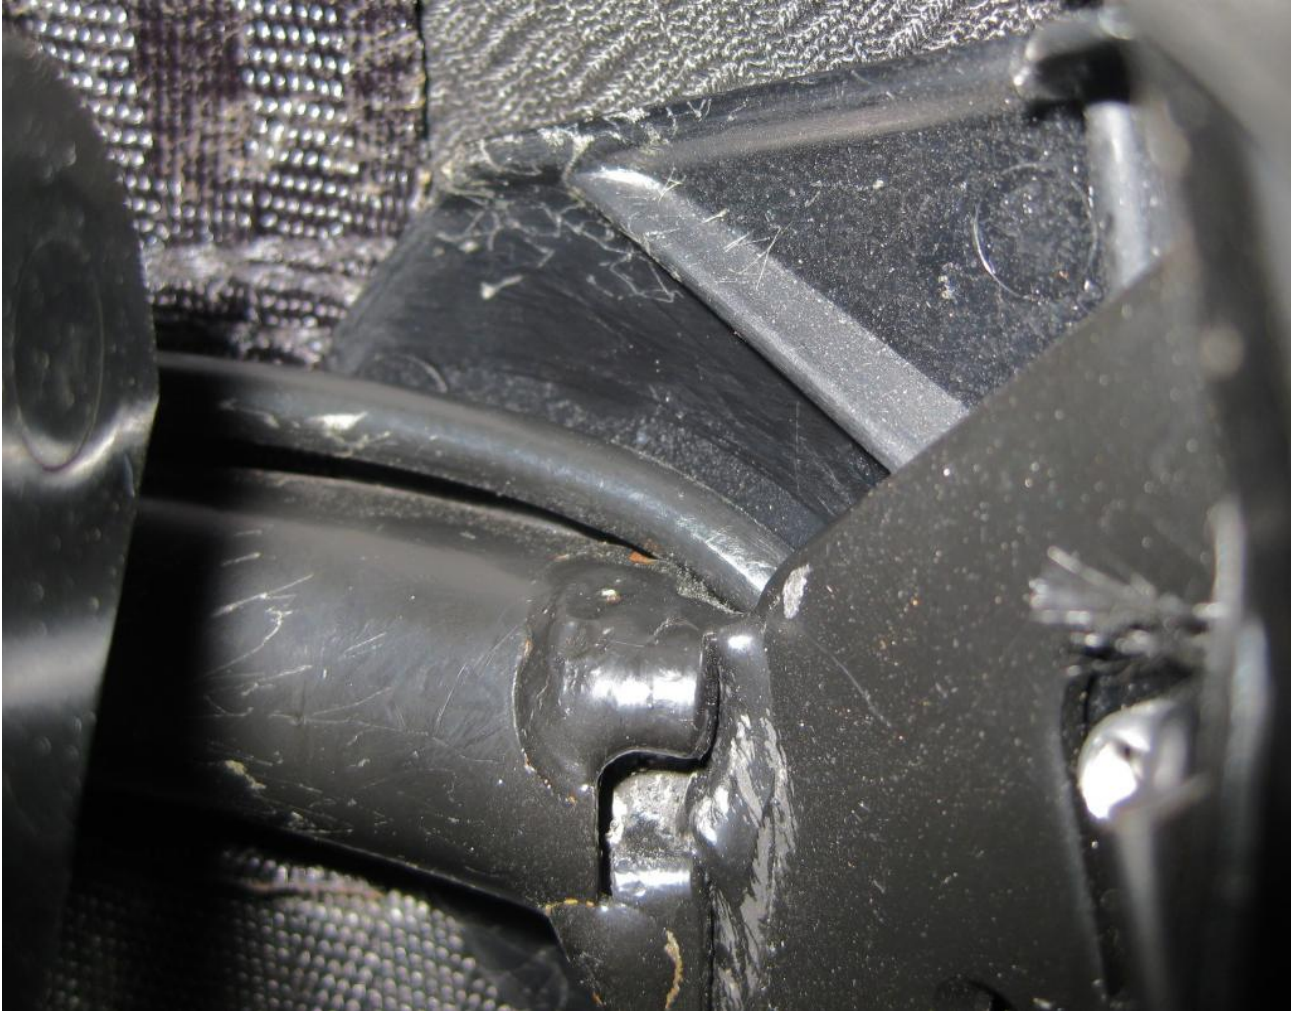
Find this area on the inside where the red circle was in step 5. Note the line will not fit through this channel with the fitting attached. Cut the fitting off and pull the line through.

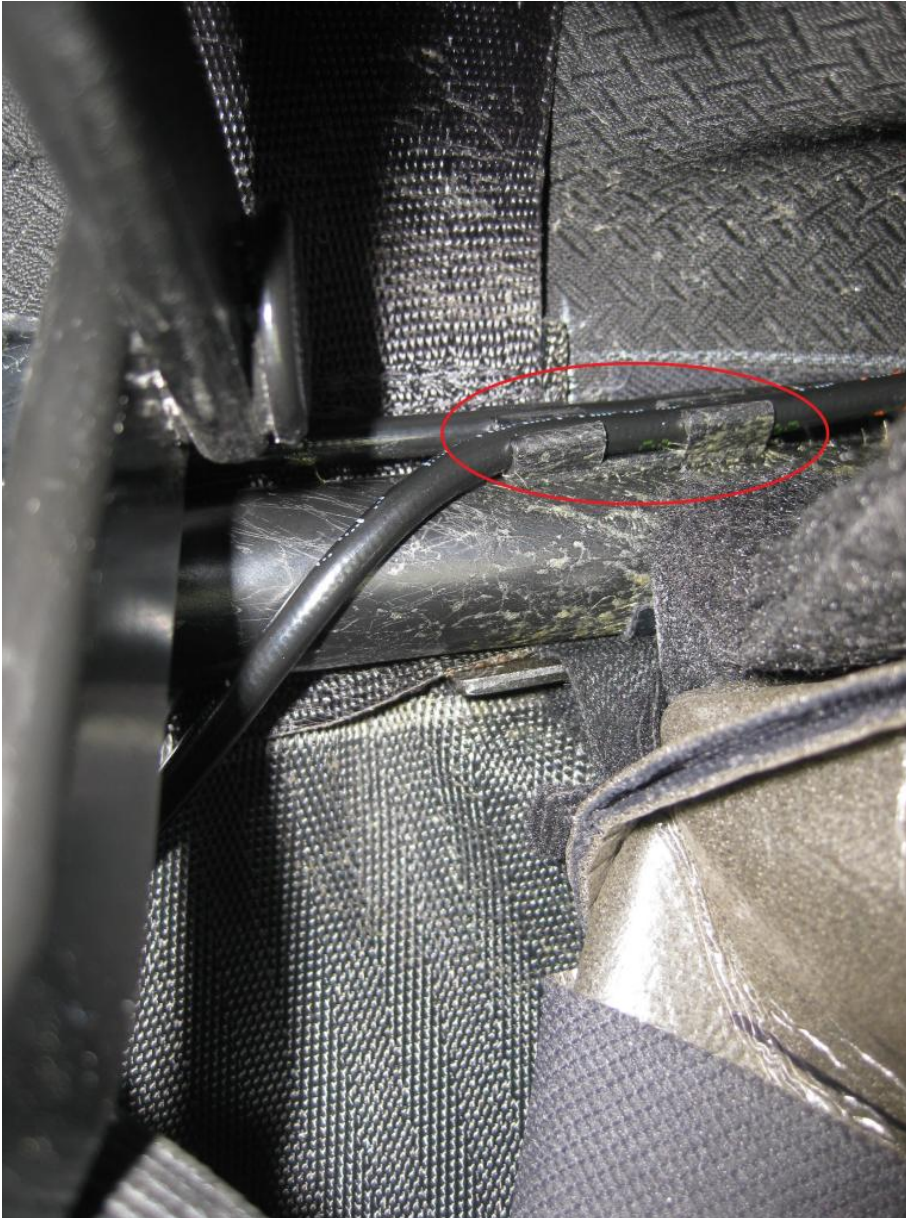
Start with the clips on the top of the tension bar and route the new line #23 down rather than across:

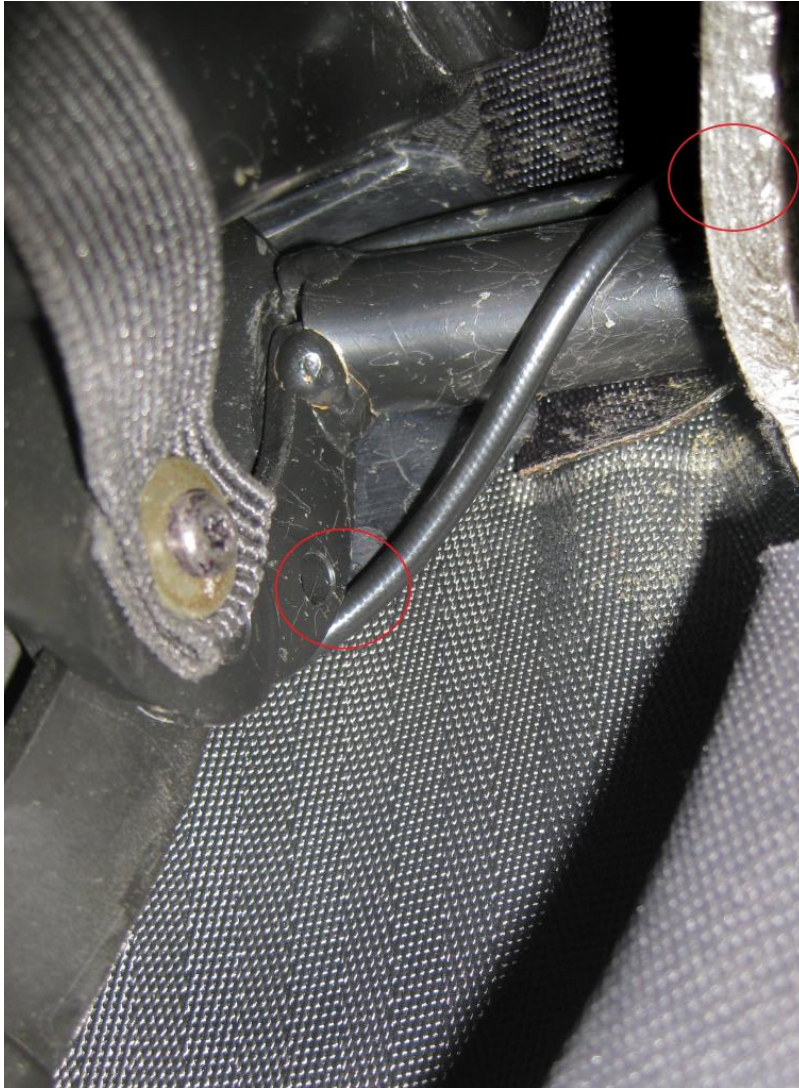
Next route the line along the back edge of the protective plate. The line should cross a small hole in a cross member.

Note: The cross member is welded to the tension bar, so it does not move and should be safe to secure the line to.

Note: The cross member supports a joint. The hole is positioned far enough away from the joint that the new route for line #23 should not interfere with the joint.

Use fabric tape to protect the line from the cross member, and a small tiewrap to secure the line at the hole.

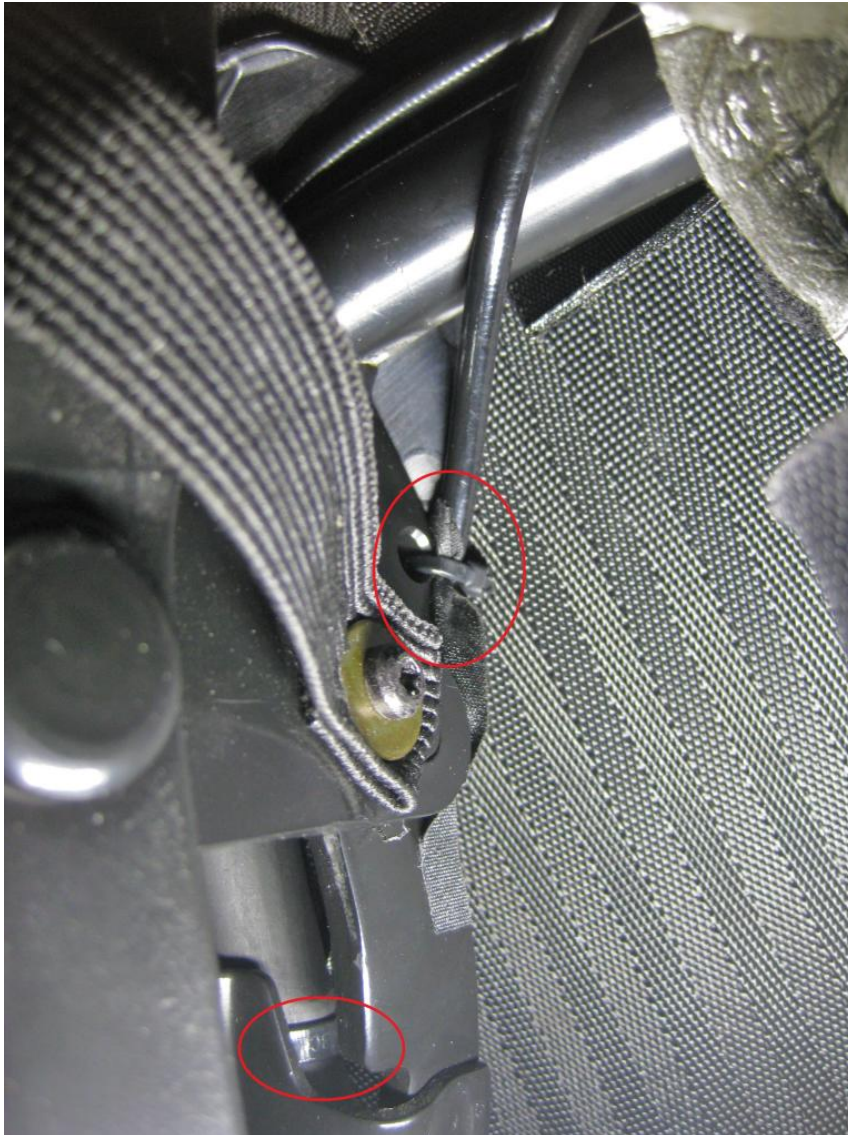
Use a medium tiewrap to secure line #23 to line #24 where the other red circle is. Reach around this area and feel for line #24. The protective rubber sleeve is anchored at this location, so it is safe to tiewrap line #23 and 24 to this.

Note: *Only pull the tiewraps "snug", don't squish the lines.*
