BMW E46 Convertible Hydraulic Line #23 Replacement Guide

Created by taylor192 of E46Fanatics.com

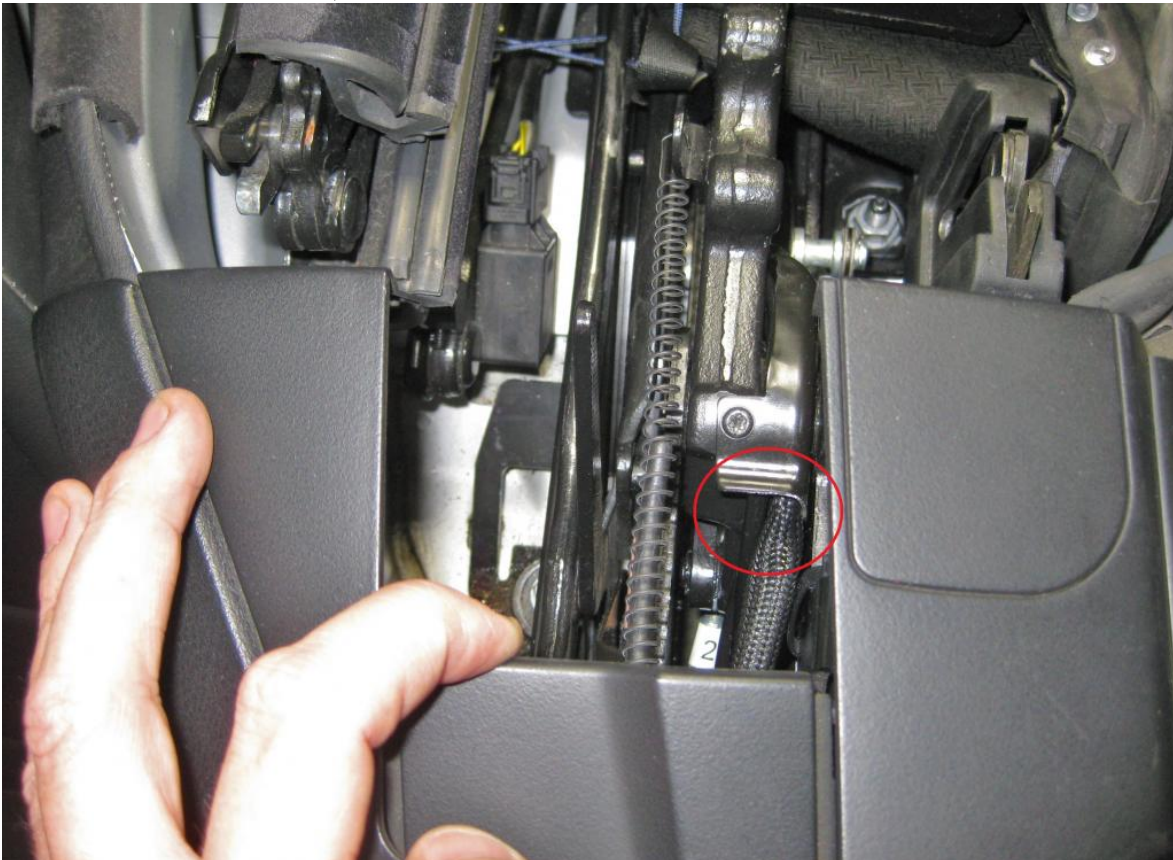
With the top down pull back this panel on the drivers side (the storage compartment lid does not need to be raised):

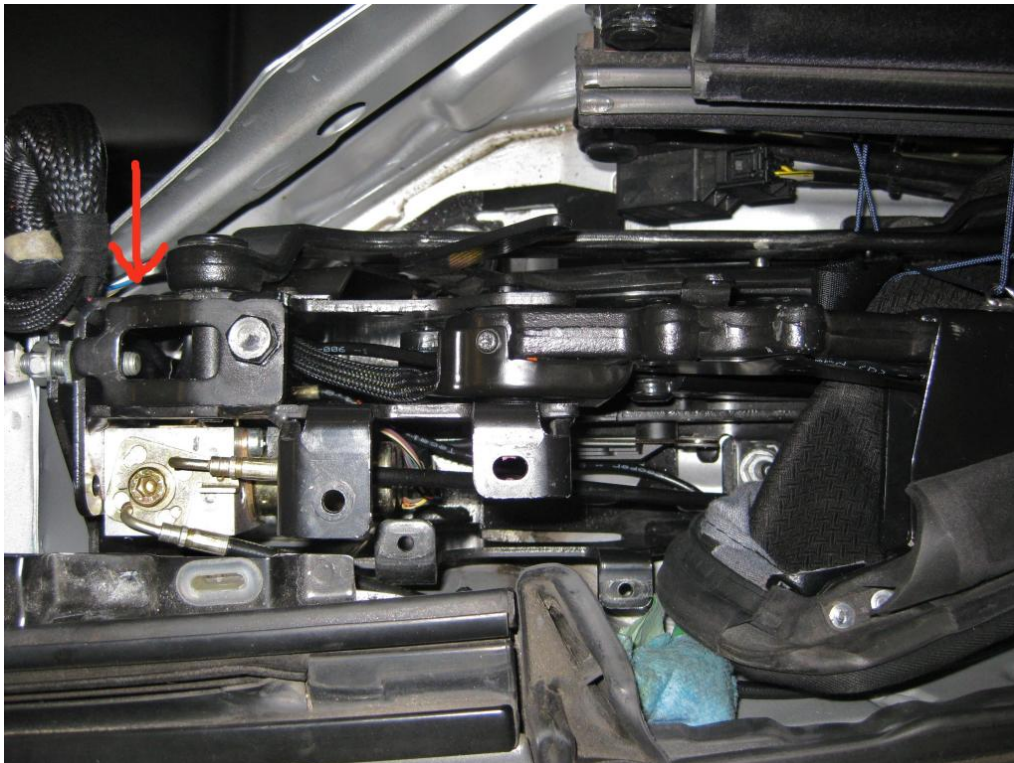
The lines are held in with a metal retainer which turns to lock the lines in. A black plastic tab locks the metal retainer in place. Using the long bent needle nose pliers pry up the black retainer, turn the metal retainer, and pull line #23 out. They will leak so have rags handy! I wrapped the ends in rags then secured the rags with tape. Access the valve block with the pliers here:

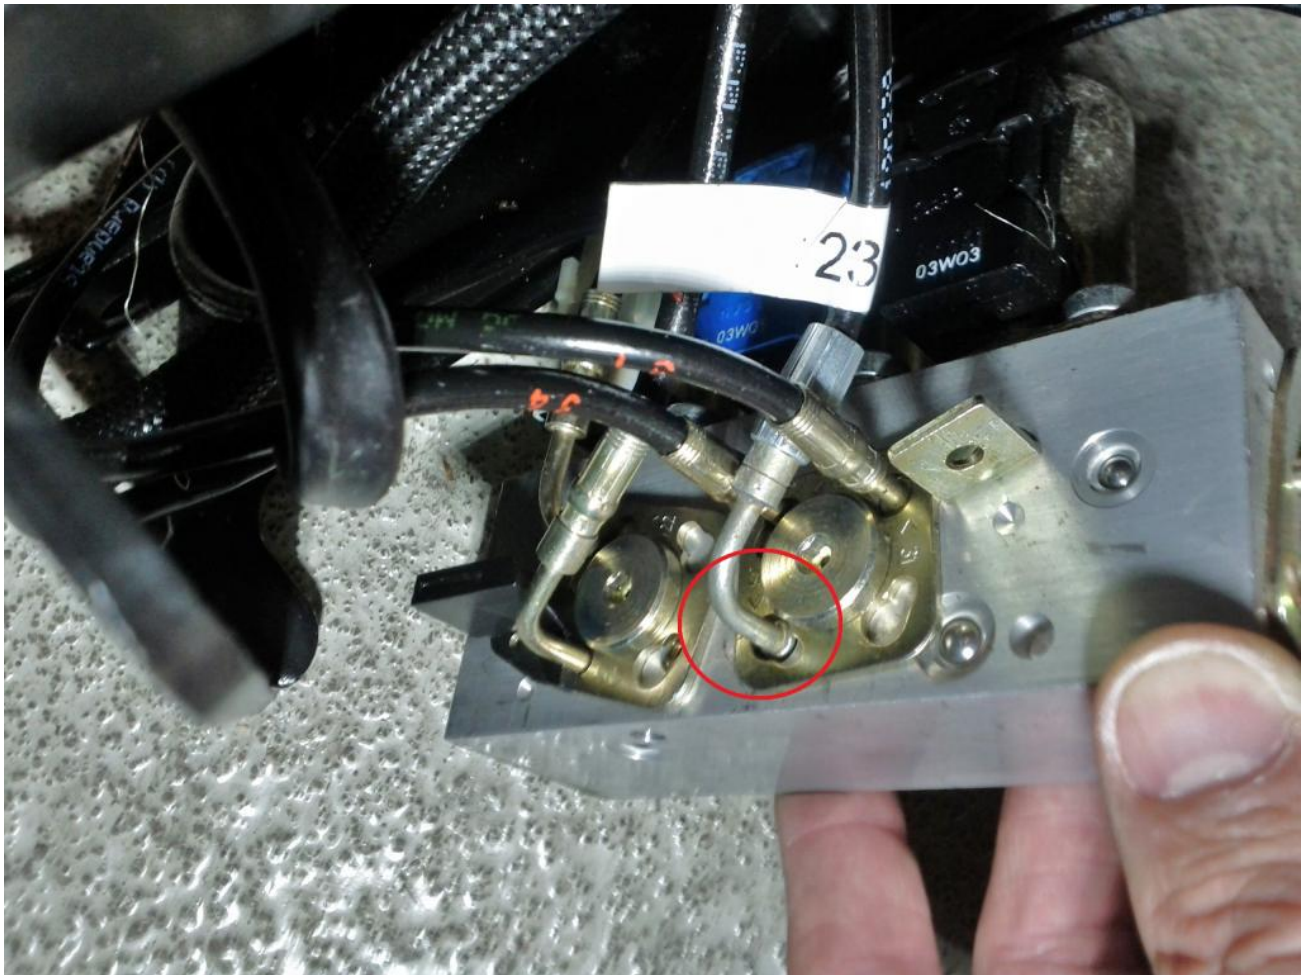
In the next photo I have removed the top from the car and removed the valve block from the top (you do not need to do this) so I could show how and where the lines connect. I've already removed the black plastic retainer and turned the metal retainer.

Reinstallation note: Reinstalling line #23 will test your patience. It is possible to insert line #23 into the valve block and attach the black plastic retainer without removing the top. It is much easier with the top removed from the car if you run out of patience (follow the steps in the Main Lift Cylinder DIY to remove the top from the car).

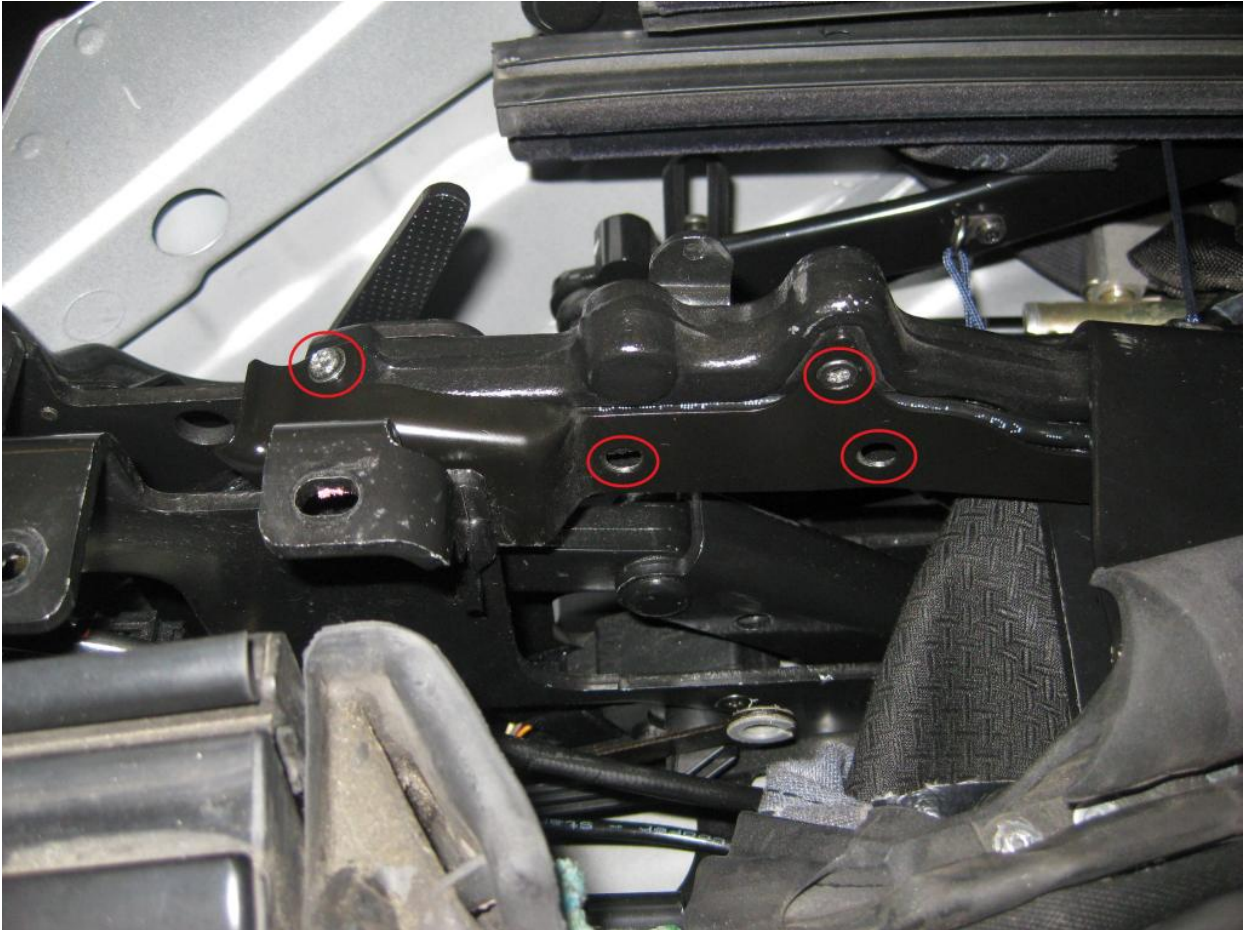
Remove the 4 #20 torx screws holding down the plate. Note: one screw may be shorter than the rest.

Pull line #23 out as far as possible and hold to the side. ***Reinstall the plate to protect line #24 and the harness before proceeding.***

Reinstallation note: When reinstalling this cover after installing the new line #23 be sure to leave some extra slack to the valve block.

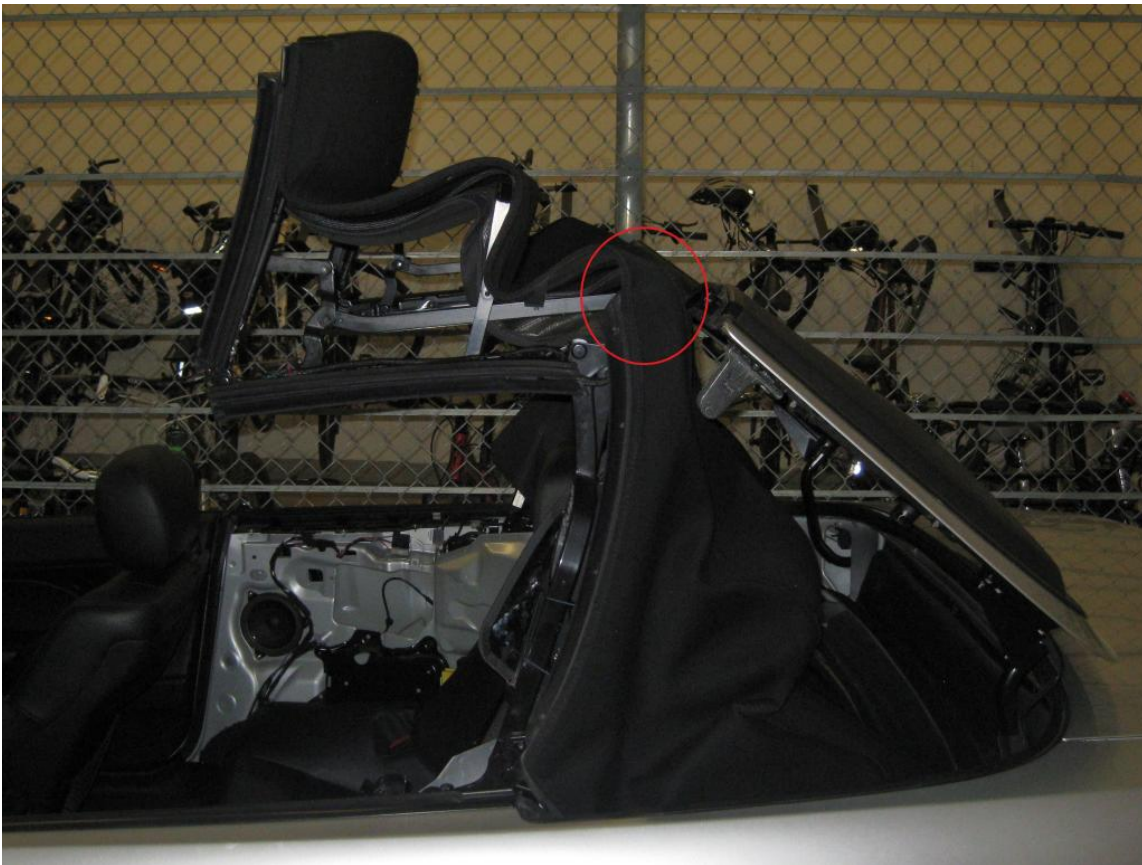
Move the top into this position. Note the red circle, you will be working in that area in step 6.

Note: *Do NOT rest the storage lid against the top as pictured. Have a friend hold it and the top, otherwise you risk damaging the top if it moves when performing steps 5 and 6.*

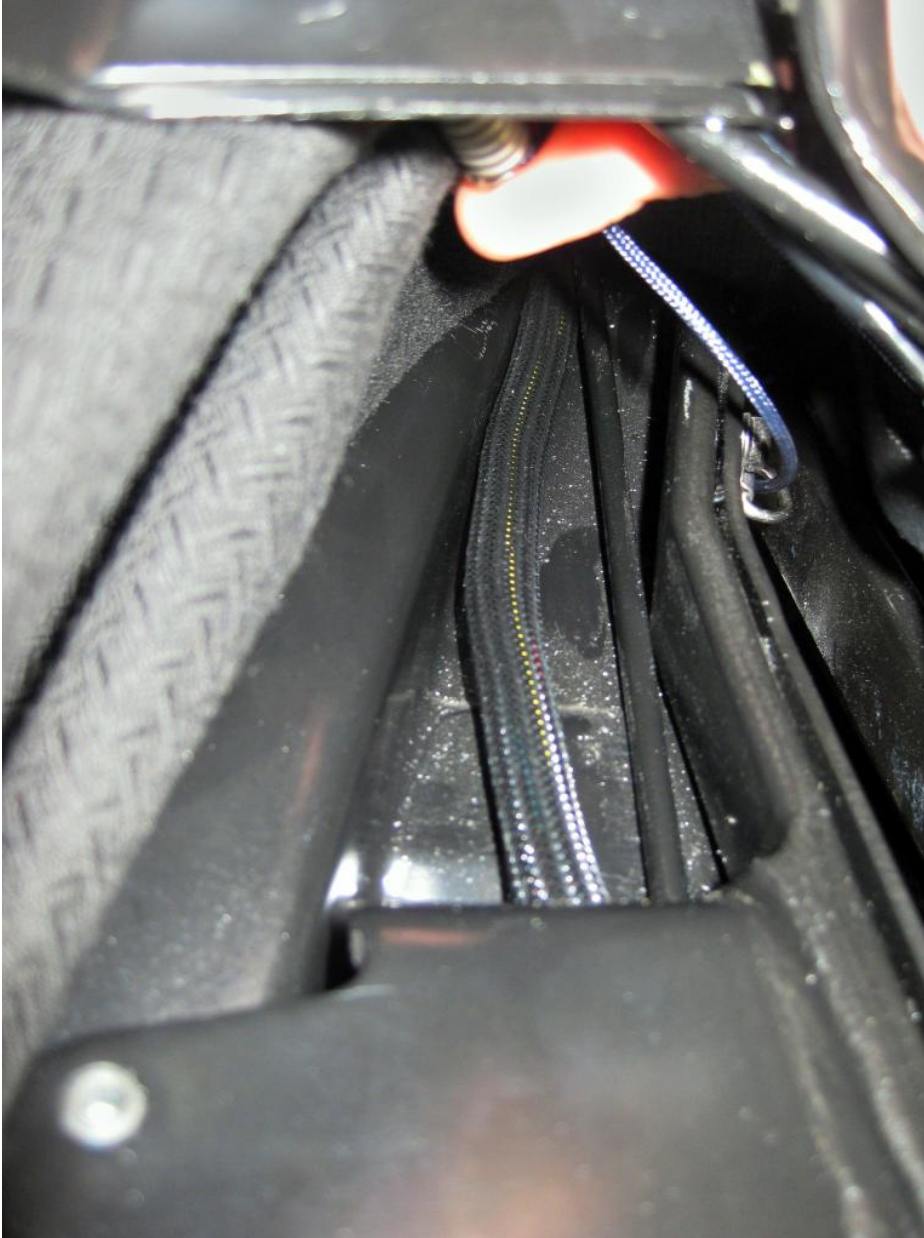
Inspect the back of the C-pillar to see how the lines run. In this photo I have removed line #23, the line pictured is line #24:

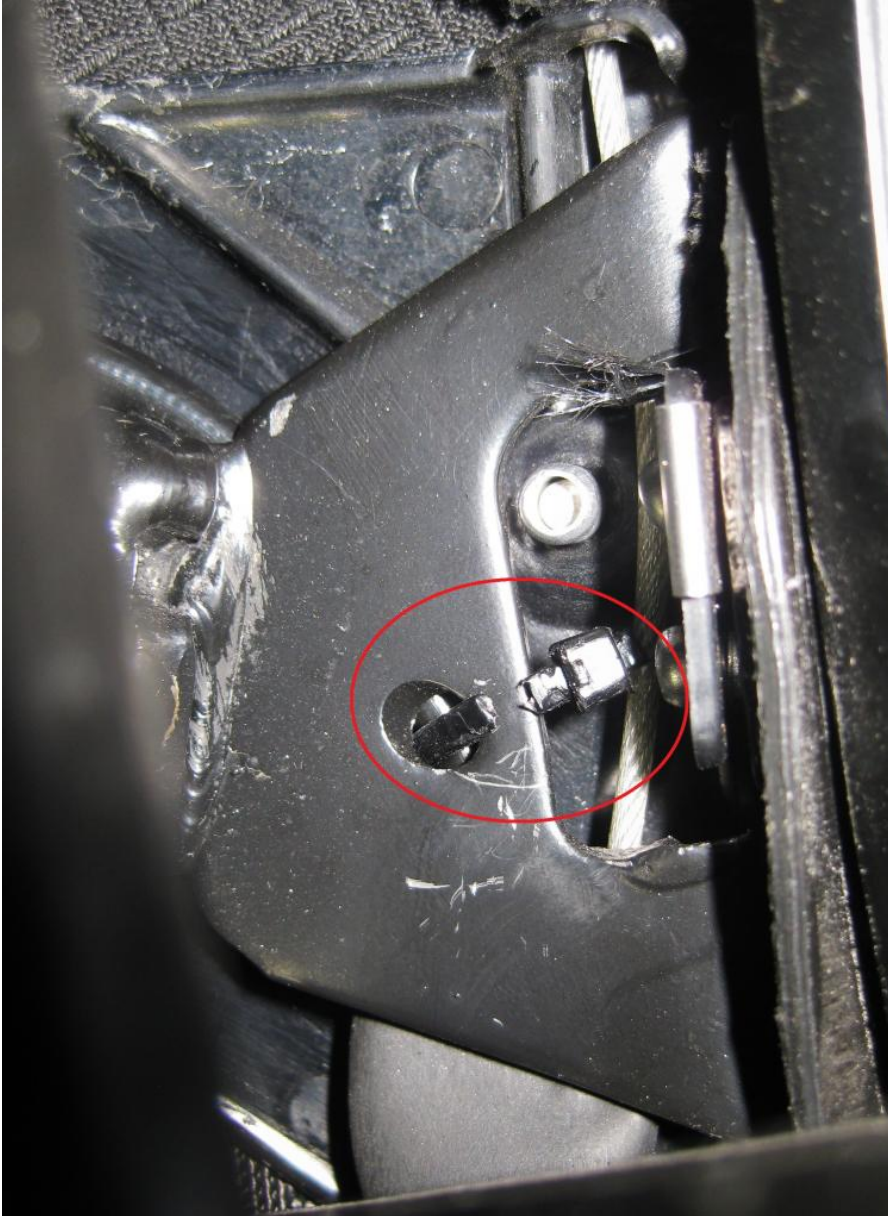
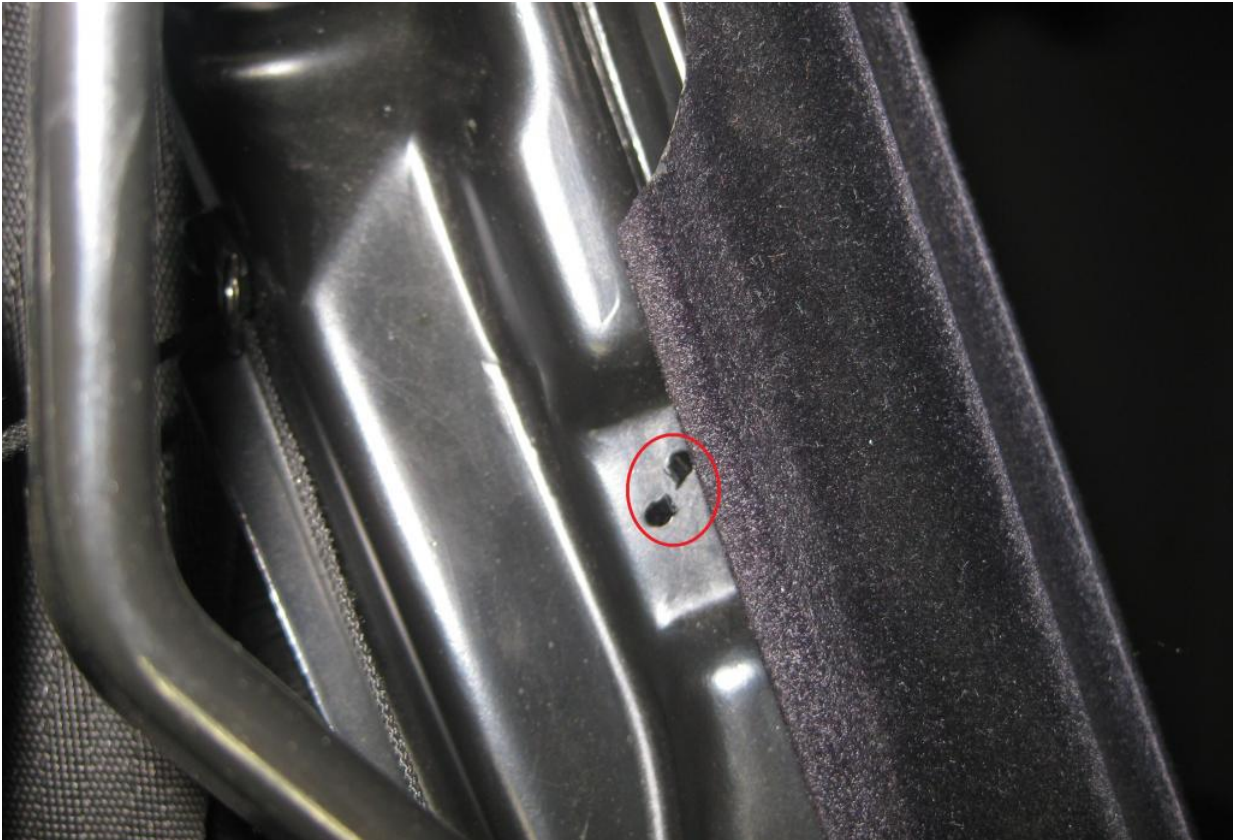
Find these 2 zipties on the front of the C-pillar and cut them.

Reinstallation note: The first ziptie will probably be impossible to reinstall, the second is just above my finger in the photo of the back of the C-pillar.

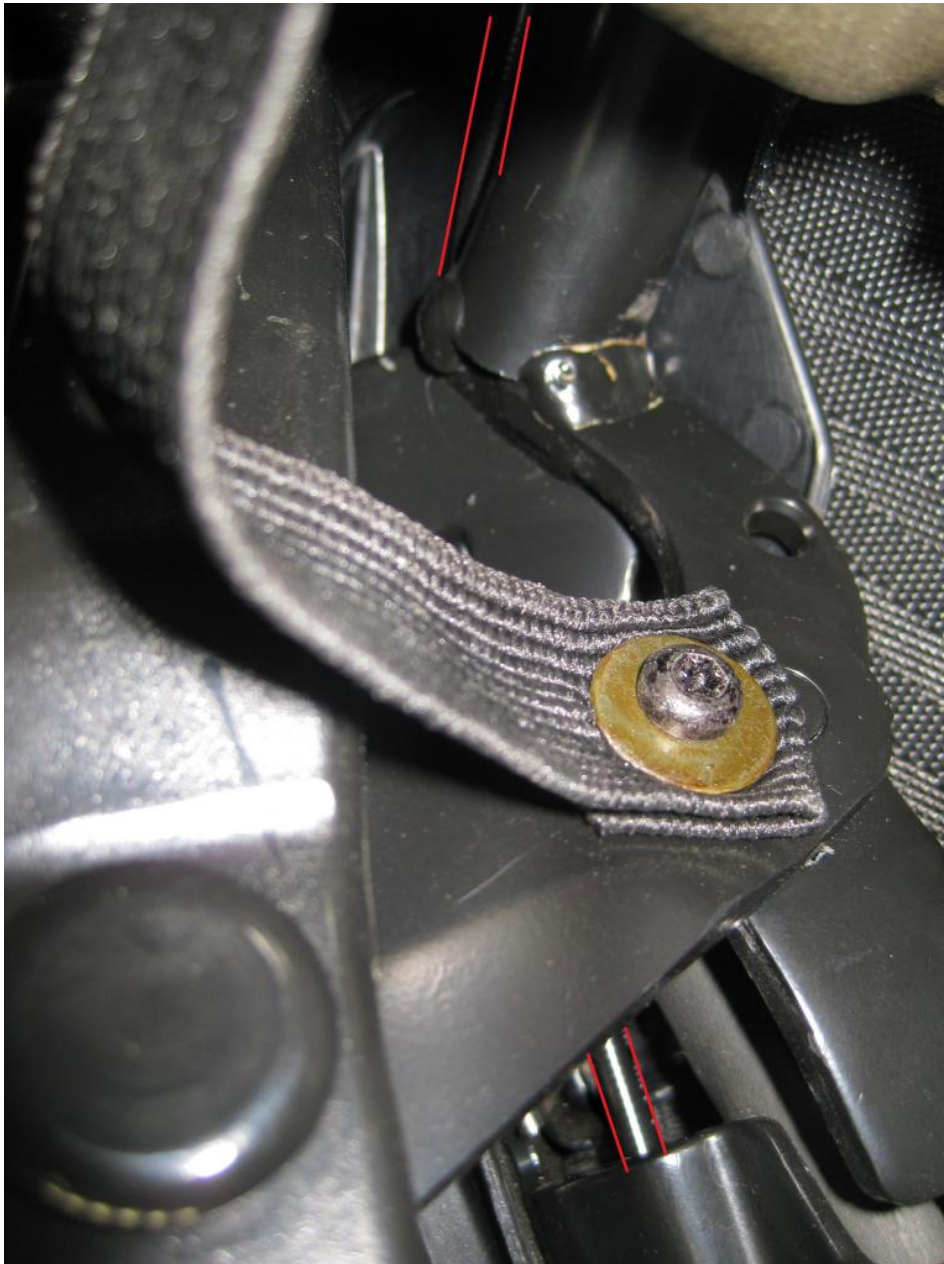
If you need more room to work you can loosen the headliner and the strings that hold the batwings. The headliner and batwing strings are held in with various #20 torx screws, here are 2 good ones to remove to gain more space:

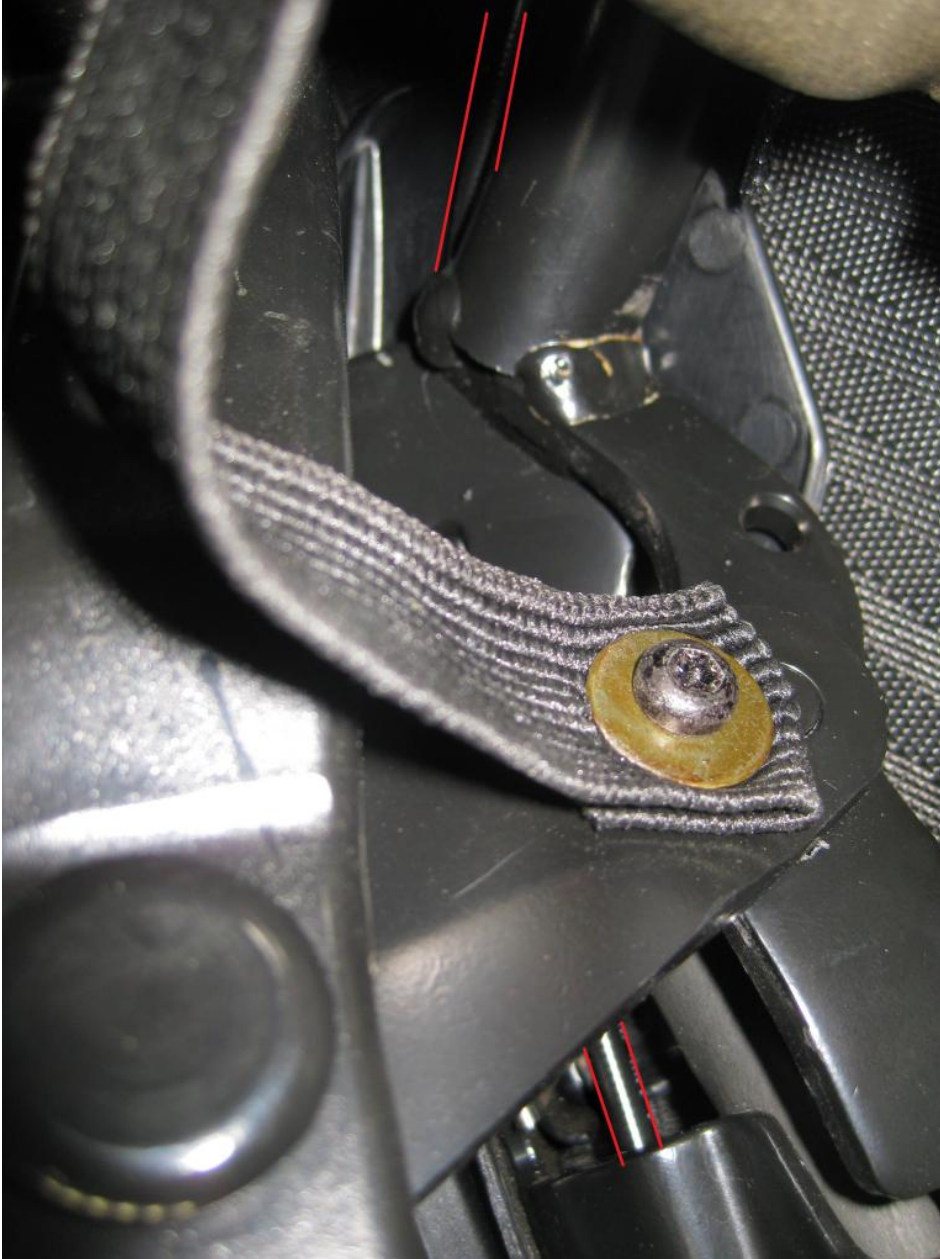
Reinstallation note: To reinstall line #23 it must be rerouted around the protective plate. First review how the line is routed (this is the passenger side, repeat on both sides):

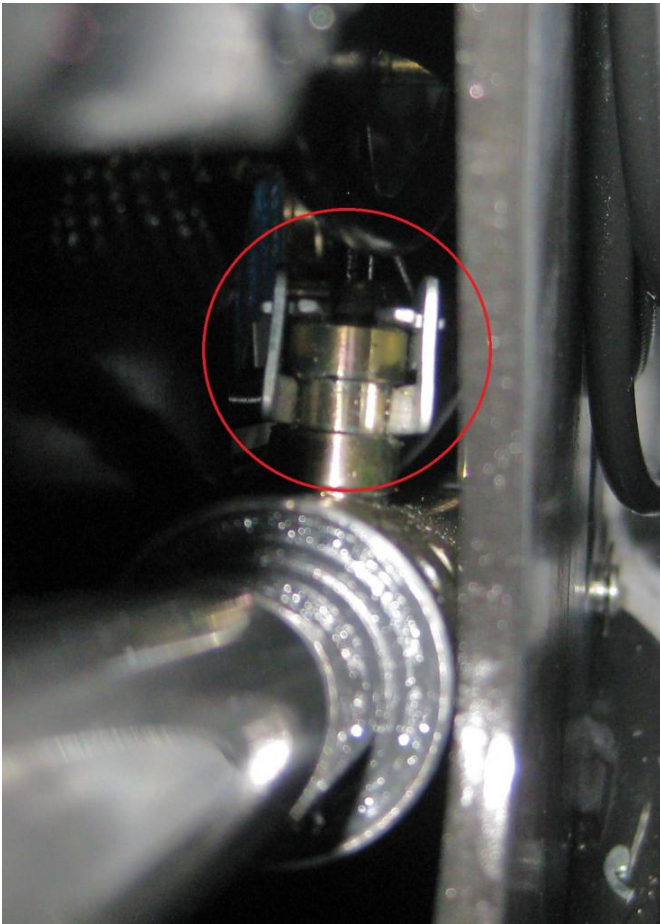
Use the long flat screwdriver to push off this clip. If the clip is facing the other way just spin it. Then pull up the line to remove. The line will leak so have rags handy!
